- 1. I write to advise on the outcomes of the examination of the contact of interest located by HMAS YARRA in position 04 13.283S, 152 28.347E in 175m of water, designated Y1.

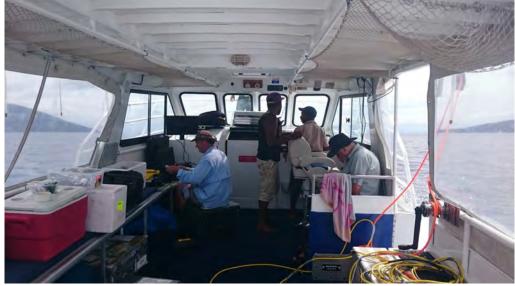
Fig 1 – MV Karavas with cantilevered pulley system for orange spectra shot line attached to the flying clump and ROV yellow umbilical in Starboard waist opening.

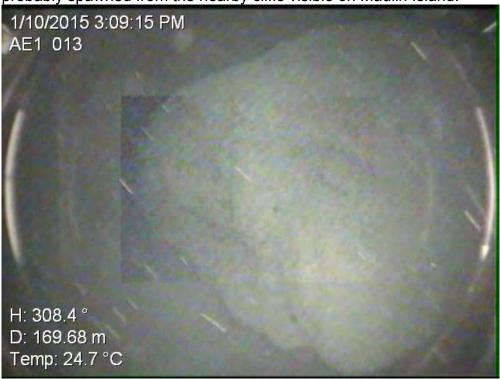
7. Y1 is a significant boulder field of 1-3m high, limestone boulders, probably spawned from the nearby cliffs visible on Maulin Island.

Fig 2 – ROV image of large limestone boulder in the Y1 location (the ROV date top left is incorrect it should read 1/11/2015).

The sea floor between the boulders is very soft silt and sand with a slope of 1:20 - 1:7.

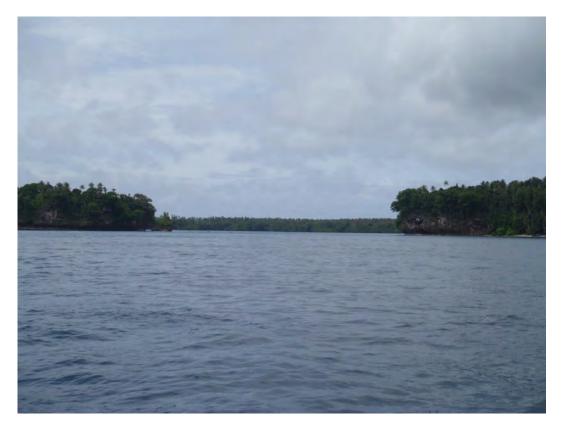
Fig 3 Passage between Jacquiot Point and Mualim Island showing undercut limestone cliffs, the possible source of the boulder field.
